# Treated Wood in Aquatic Environments

A Specification and Environmental  
Guide to Selecting, Installing and  
Managing Wood Preservation Systems  
in Aquatic and Wetland Environments

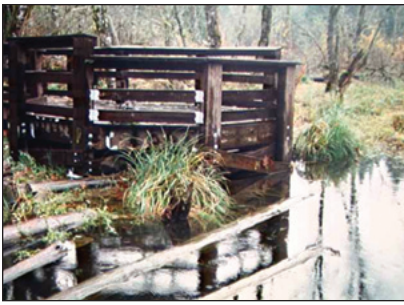
ACZA

The 1,800-foot long boardwalk was built to provide public access to this pristine, otherwise inaccessible environment. Different sections of the boardwalk were constructed with ACZA, ACQ-B or CCA-C preserved wood. Soils, wetland sediments, the water and invertebrates living around the structures were carefully sampled and analyzed before construction began and periodically afterward for one year. Conditions at varying distances from the structures were compared with those at a similar control structure built of untreated wood in an isolated part of the wetland. The results of this study were published by the U.S. Forest Service in 2000.

Each of the structures behaved differently but their metal loss rates were consistent with laboratory leaching studies. The full report contains a detailed description of the metal concentrations observed in the water and sediments within 12 meters of each structure during the entire study. For waterborne systems, copper is the metal of concern because aquatic organisms, unlike humans, are much less tolerant of copper than they are of arsenic, zinc or chromium. If the levels of copper from treated wood were maintained at less than toxic thresholds, then other chemicals used in waterborne preservatives would simply not be present at concentrations causing concern. The following discussion will focus on the results for the CCA-C structure because this preservative was at the time, the most commonly used product in the U.S.

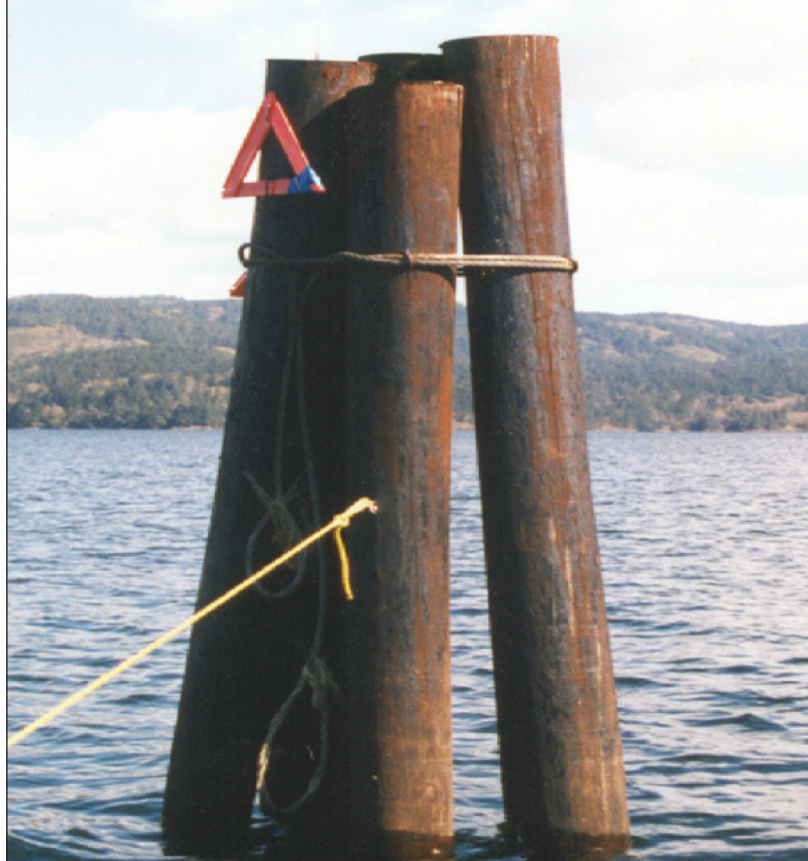
*New creosote-treated dolphin used to evaluate creosote in Sooke.*

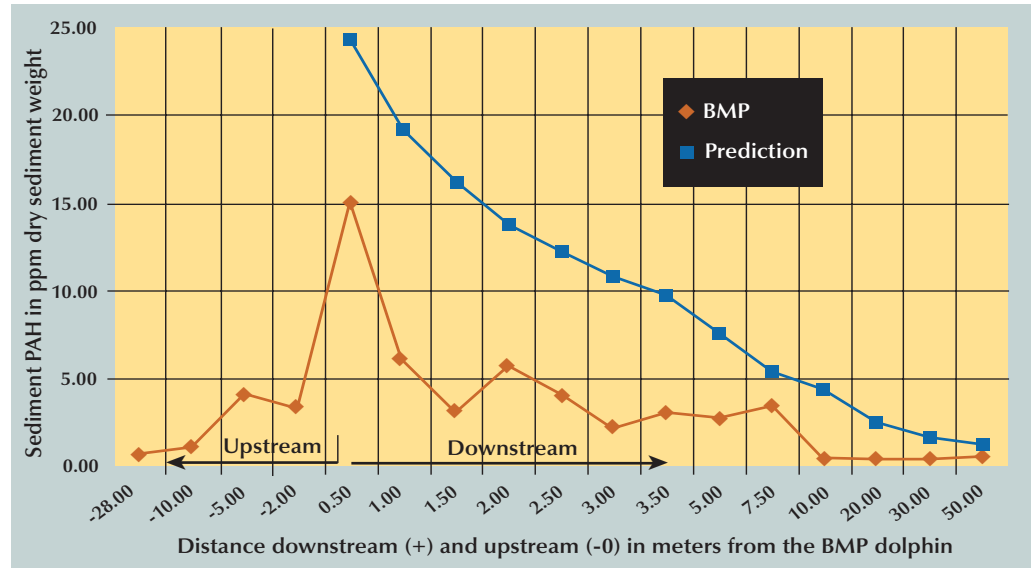
- Creosote did migrate from the piling and accumulate in sediments downcurrent from the piling. As shown in Figure 4 below, the actual accumulation of PAH in sediments (red line) was less than that predicted in the model (blue line). These sediment concentrations also peaked earlier and declined faster than predicted. These models have been field-verified repeatedly over the last six years. In every case, they have proven conservative from the environment's point of view – that is, predictions of PAH accumulation were higher than what was actually observed.

As previously noted, concentrations of PAH in the sediments peaked earlier and declined more quickly than predicted by the models. The fact that there were lower-than-expected levels of PAH is an important environmental observation. Perhaps more important was the fact that the piling provided habitat for an astounding array of aquatic life with no significant or lasting adverse impact from the creosote treatment.

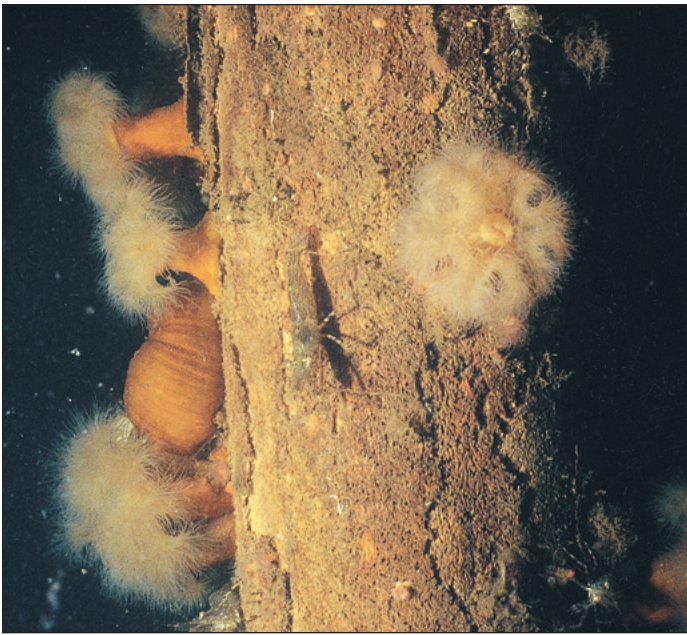
*The untreated piling were deteriorating and did not support a vibrant fouling community*

By the end of the study, all of this biological activity had exceeded the assimilative capacity of the sediments around the piling. They were anaerobic and contained very high levels of sulfide. The resulting sediment toxicity had nothing to do with the creosote treatment. In fact, these conditions were as bad or worse at the untreated control dolphin. Why? Because the untreated wood was quickly being consumed by marine borers (toredos, bankia and limnoria). Few fouling organisms were found on these piling because as soon as a community established itself, the wood failed and the organisms fell to the bottom where they were consumed by predators.

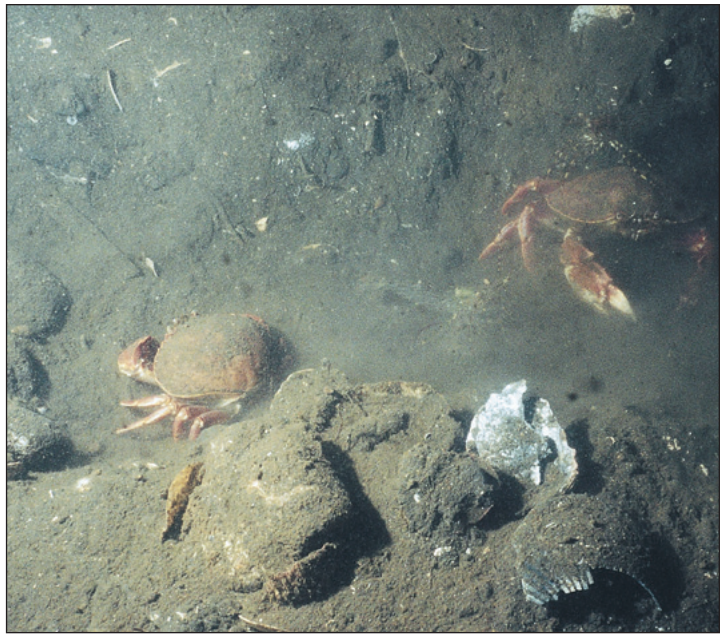
*Dungeness crabs foraging on mussels dislodged by starfish around the new creosote-treated dolphin*

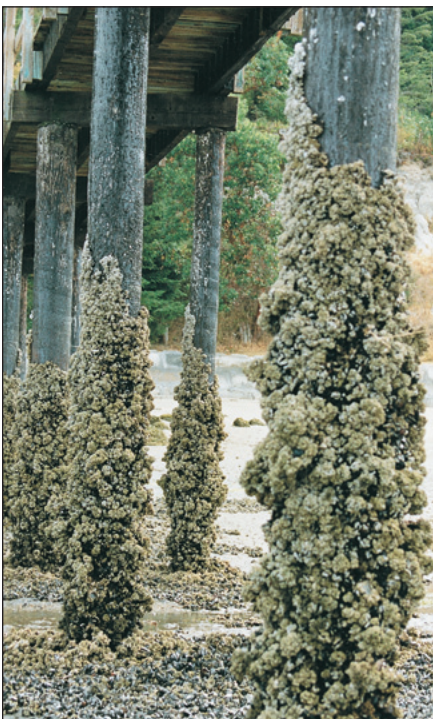
*The personal use pier shown here is constructed of creosote-treated piling with ACZA-treated walkways*

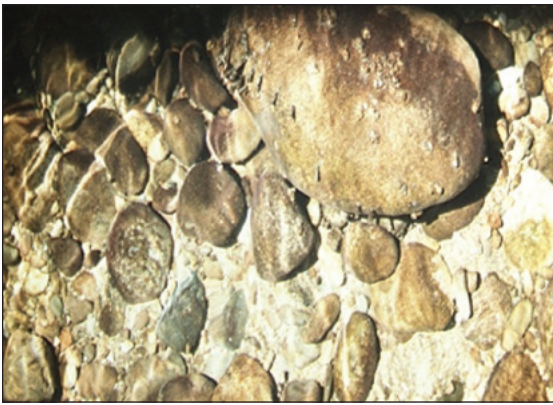
Example of substrate in the Satsop River where salmon spawn

These two bridges were located over salmon-spawning rivers with sand-gravel and cobble substrates supporting a vibrant community of pollution-intolerant aquatic insects in the Orders Ephemeroptera (mayflies) and Trichoptera (caddis flies). The larvae of these Orders are generally associated with fast-moving oligotrophic streams and rivers. The biological response of this sensitive community is illustrated in the figure below. It describes sediment pentachlorophenol concentrations ( $\mu\text{g}/\text{kg}$ ) in red; the proportion fine-grained sediments (sand, silt and clay) in blue; biological response described by the number of species (green); and the abundance of invertebrates (brown).

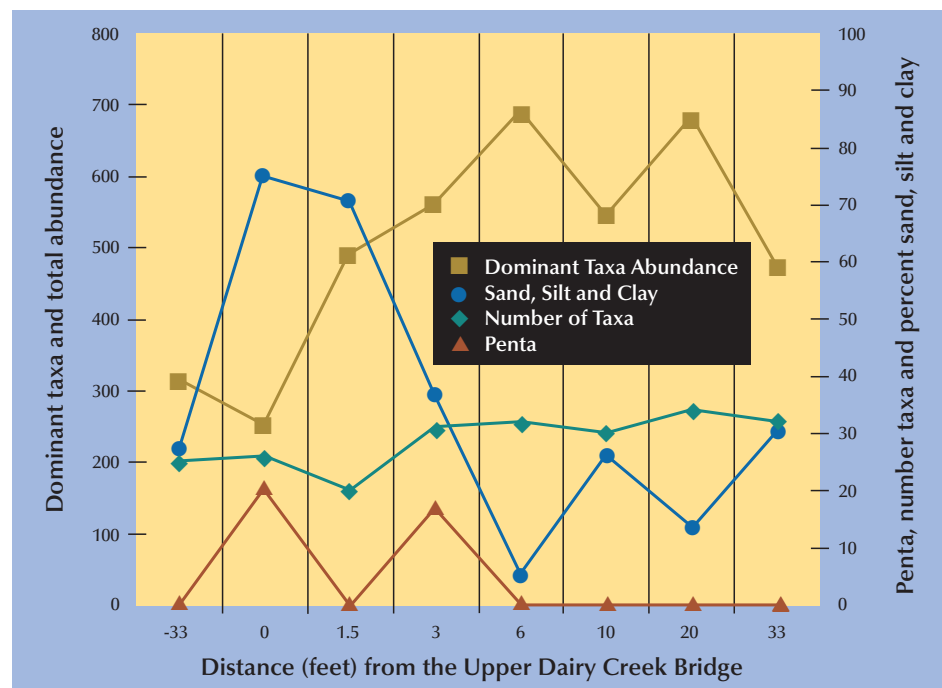
Figure 5

Note that the number of species and the total abundance of invertebrates were much higher three feet downstream from the bridge's drip line where the proportion of fine sediments dropped from 70 to 80 percent. Also note that invertebrate abundance peaked where the proportion of fines decreased to between five and 12 percent. There were as many species and as many animals downstream from the bridge as there were at the upstream control. And there was essentially no correspondence between invertebrate community and the small amount of pentachlorophenol observed under the bridge and at the station located three feet downstream. Amphipod (*Hyalella azteca*) bioassays also found no evidence of toxicity in sediments from either of these pentachlorophenol-treated bridges. The invertebrate community was far more influenced by the substrate type than by the bridge.

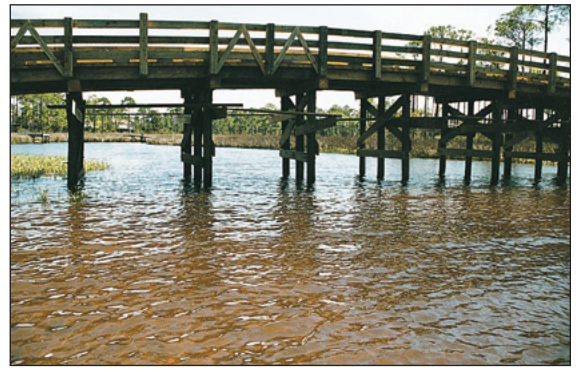
Horseshoe Bayou Bridge

Two bridges, each constructed entirely of CCA-C-treated wood, were evaluated in Sandestin, Florida. The Horseshoe Bayou Bridge, the largest, was designed to carry a 20-ton load. Its 160-foot span crossed a pristine marine estuary at the entrance to Horseshoe Bayou. Construction was just being completed when the survey was conducted. This timing was considered important to observing any increase in the concentration of dissolved metals during the period right after immersion when leaching is greatest from CCA-C-preserved wood.

The reason for the increase illustrates an important point in the construction of treated-wood structures. As previously noted, this is a truly massive bridge. One thousand four hundred fifty-eight holes were drilled in the bridge to bolt together the heavy-duty treated-wood railing. Each hole was 3/4" in diameter and approximately 14" long. The drill shavings were not contained and they blew into the estuary where they could be seen on the bottom all around the bridge.

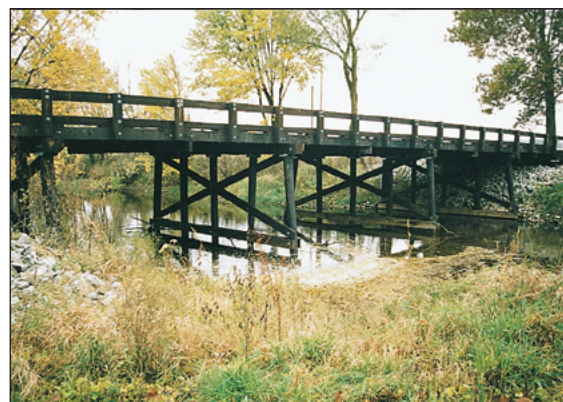
Pipe Creek Bridge

Pipe Creek flows through corn country and carries a heavy load of sediment. Current speeds along the chosen sampling transects were very slow at  $<1.0 \text{ cm/sec}$ . From an environmental point of view, both bridges behaved similarly. Slightly higher PAH concentrations were observed in sediments near the 2-year-old Bridge 146 than were found under the 8-year-old Bridge 148. The following discussion describes the results at new Bridge 146.
